# RRMT0055

# RRMT-0055: Transmission Air Supply Pressure Sensor (TASPS) Replacement Service Procedure - Endurant HD, XD and PACCAR TX-12, TX-18

Date: December 04, 2025

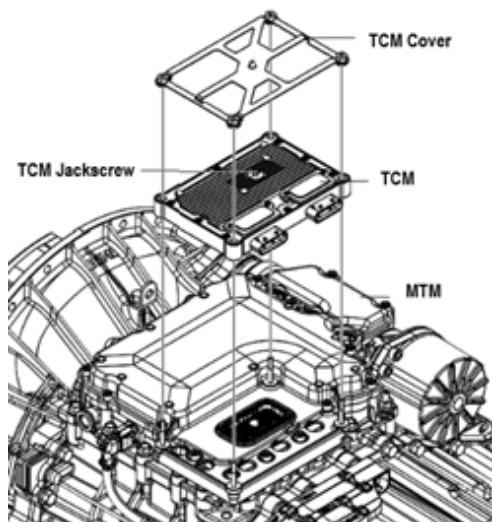
1. Unscrew 4 TCM Cover nuts (10 or 13 mm) and remove TCM Cover.
2. Unscrew TCM 7 mm Jackscrew. Lift and remove TCM for MTM.

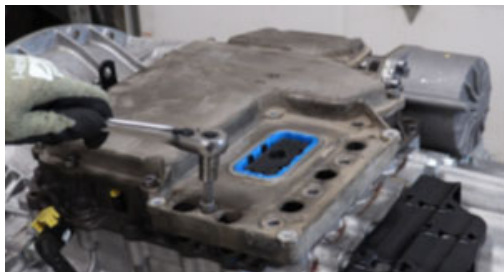
1. Remove 16 MTM Cover MTM Housing T45 cap screws.

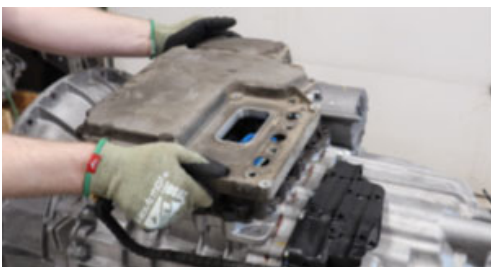
2. Remove MTM Cover.

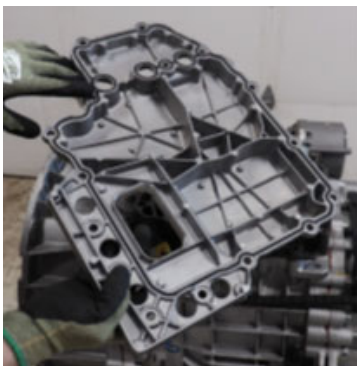
3. Inspect MTM Cover O-ring, press in place seal, for damage.
  - a. If **no** damage, go to **Step 4**.
  - b. If damaged, replace MTM or O-ring if available.

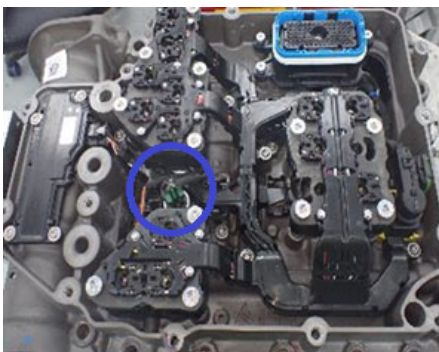
4. Locate the TASPS.

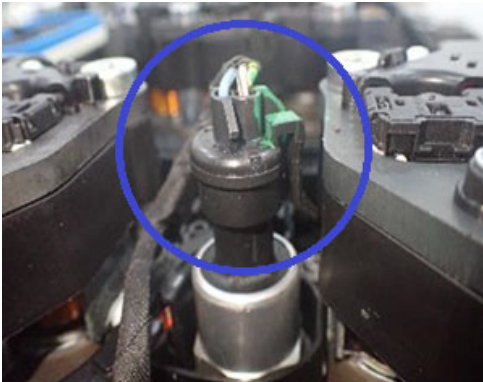
5. Inspect 3-Way TASPS Connector, confirm connector is properly seated and latched.
  - a. If connector is properly seated and latched, go to **Step 6**.
  - b. If connector is **not** properly seated or latched, record findings and go to **Step 6**.

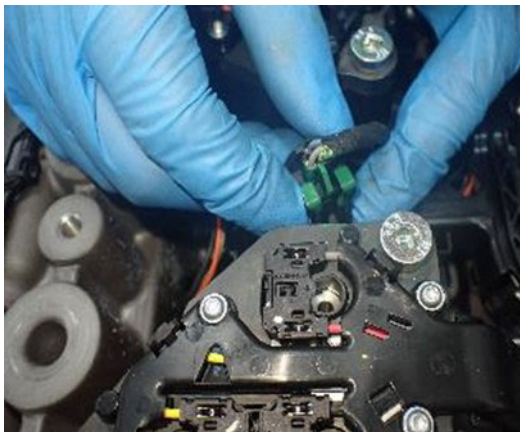
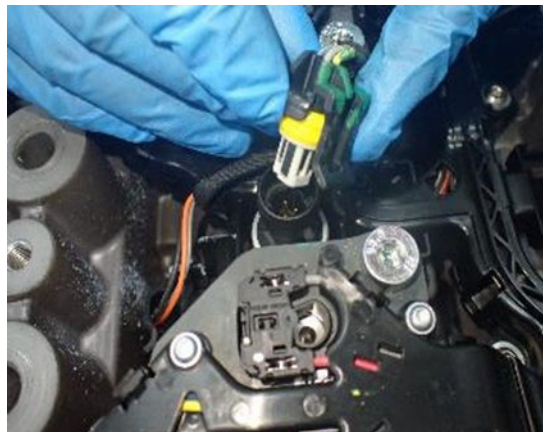
6. Inspect 3-Way TASPS Connector wires, confirm wires are not damaged and terminals are properly seated/locked into connector.
  - a. If wires are damaged and/or terminals not properly seated/locked into connector, record findings and **replace MTM**.
  - b. If **no** wire damage and terminals are properly seated/locked in connector, go to **Step 7**.
7. Carefully disconnect the 3-Way TASPS Connector by moving the retaining clip aside and gently pulling on the connector.

**Note:** Ensure yellow connector seal and white terminal clip remains on the harness side of 3-Way TASPS connector.

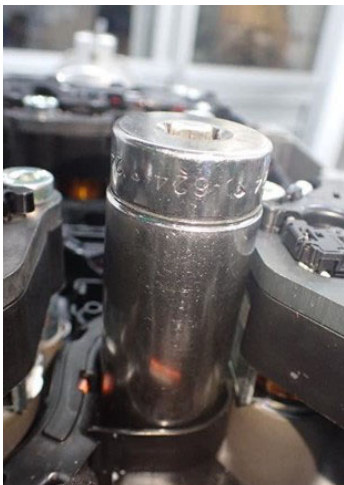
- Using hand tools, remove TASPS using a 24mm thinned walled deep socket.

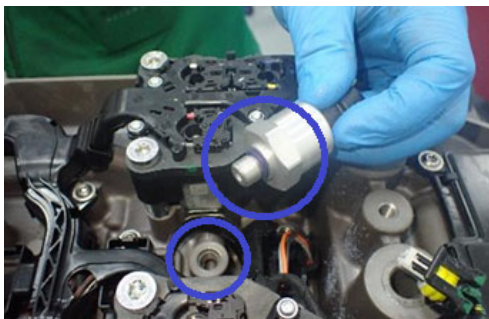
- Inspect removed TASPS and MTM side of TASPS threaded opening, ensure O-ring came out with sensor and opening is free of debris.

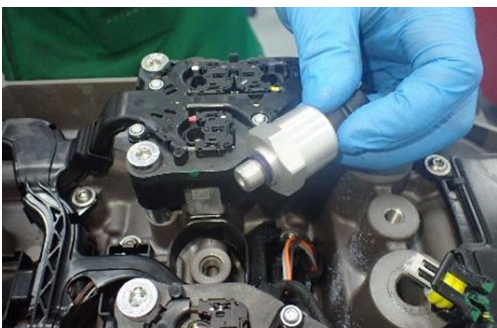
- Inspect new TASPS and ensure O-ring is installed.

- Inspect MTM side of TASPS threaded opening and ensure opening is free of debris.

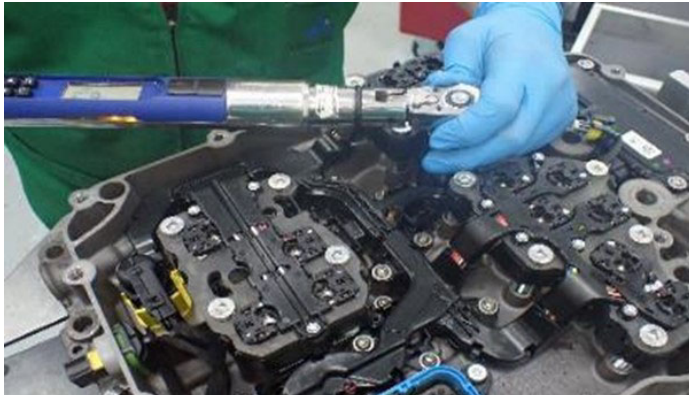
12. Install replacement TASPS and torque to **10 Nm** (89 lb-in).

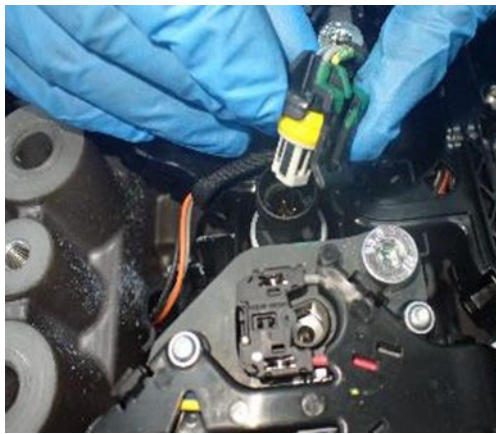
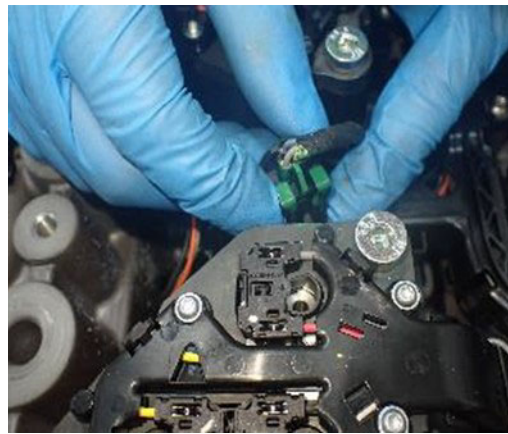
13. Carefully connect 3-Way TASPS Connector, ensure connector is seated and latched. Go to **Procedure C**.

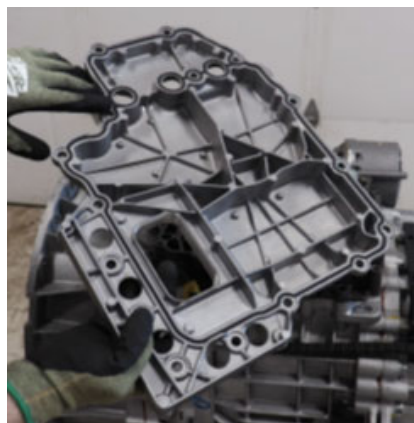
1. Inspect MTM Cover O-ring, press in place seal, ensure O-ring properly seated in groove and wipe clean with a lint free cloth.

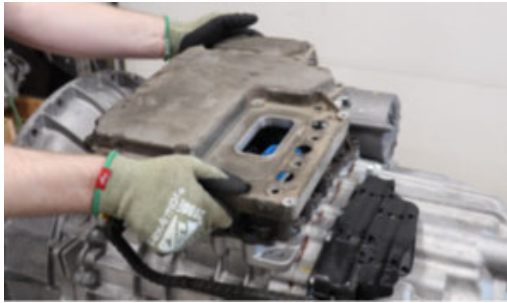
2. Inspect MTM Housing, cover sealing surface, wipe clean with a lint free cloth.
3. Install MTM Cover to MTM Housing.

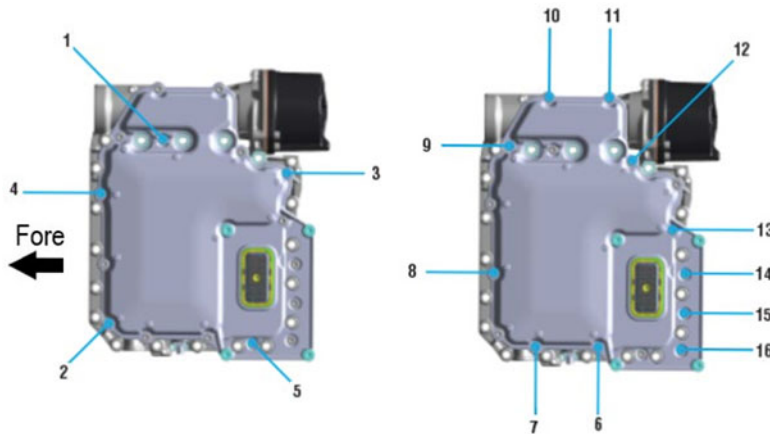
4. Install 16 MTM Cover to MTM Housing T45 cap screws.
5. Torque MTM Cover cap screws 1 through 5 and 6 through 16 to 23-27 Nm (17-19 ft-lb) as shown in the torque sequence below.

**CAUTION:** Follow the MTM Cover cap screw torque specification and sequence as shown. Failure to follow torque specification and sequence may cause in an improper seal between the cover and housing resulting in water ingestion.

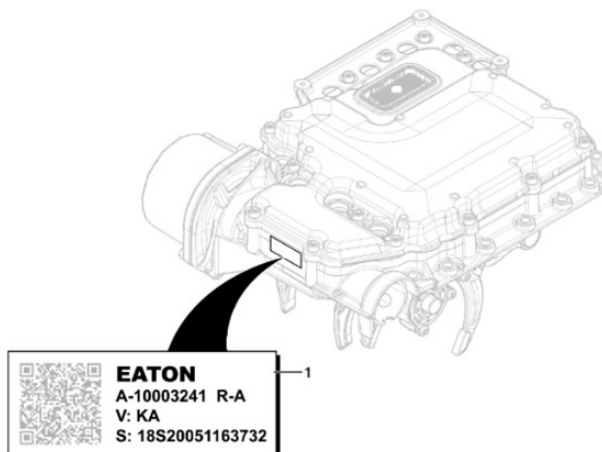
6. Re-torque MTM Cover cap screws 1 through 16 to 23-27 Nm (17-19 ft-lb) in a crisscross pattern.
7. Locate MTM parts label (1).

- Using a permanent black marker, place a dot on the MTM parts label as indicated below. Go to **Procedure D**.
